Geotechnical and infrastructural damage due to the 2016 Kumamoto earthquake sequence

S. Bhattacharya¹, M. Hyodo², G. Nikitas¹, B. Ismail³; H. Suzuki⁴, D. Lombardi³, S. Egami⁵, G. Watanabe², and K. Goda⁶

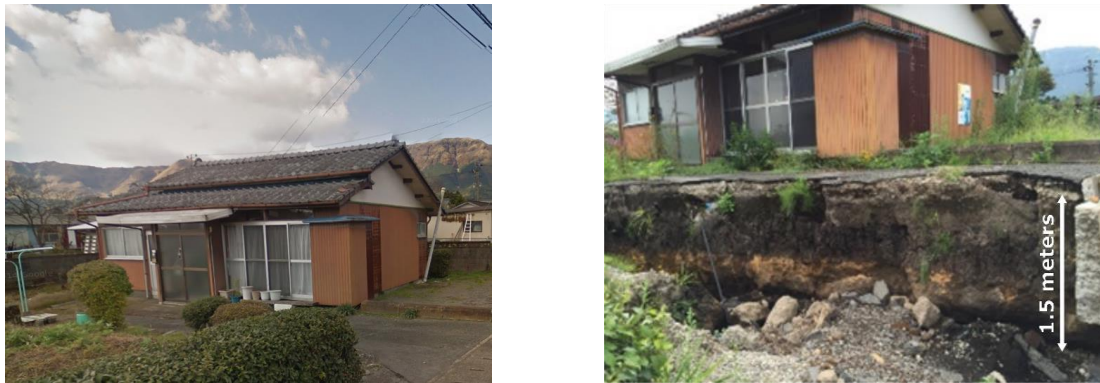
In the near-fault region, the effects of the ground deformation were remarkable: buildings and infrastructure that were directly above the fault rupture were damaged severely. The crustal deformation due to the mainshock was observed as ground surface rupture at many locations along the Futagawa fault. At several places, ground deformation up to 2 m was observed. Figure 3 shows surface fault movement of 1.5 m observed in Aso City (Uchinomaki area) and the private house narrowly escaped severe damage. The secondary damage was caused by landslides and other ground failures, including liquefaction, settlement, and lateral spreading along rivers and coastal areas. The earthquake damage was widespread over the rural areas of Kumamoto Prefecture.

Figure 3 (a): Subsidence due to fault movement close to buildings [Before and after the earthquake]

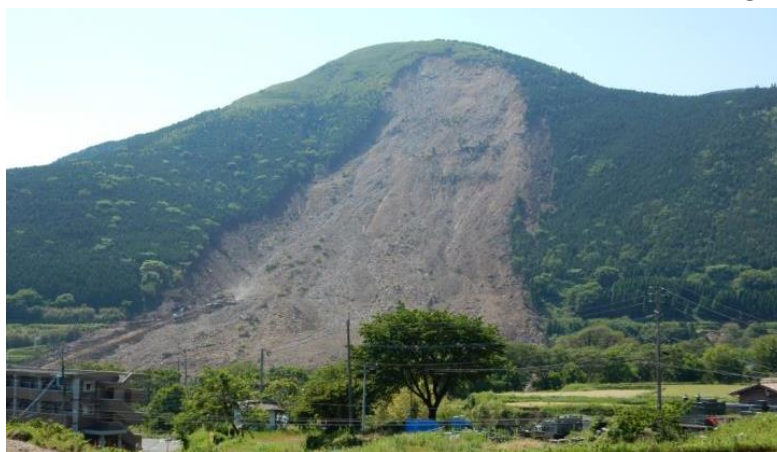
Typical landslides were observed at different locations including Aso Bridge and Minami Aso, see Figure 4. Severe landslides and surface fault rupture have been observed around the Minami Aso area. The hazards include mud and debris flow, applying kinematic loading on infrastructure, such as bridges. It has been reported that 10 people were killed by large-scale landslides in the Minami Aso area. Furthermore, large-scale landslides near Choyo Bridge were also observed. The landslides were located at the downstream of Aso Bridge where significant damage to the slope and bridge occurred. Other landslides were located west of the Minami Aso area, near Nishihara Village.

Figure 4: Landslide near Aso bridge area.

Typical landslides damage noted are at Aso Bridge (near the student hostel of Tokai University). The slope angle was roughly 20 degrees and large flow of debris, including both rock and soil at huge quantity, was observed. Because of this large landslide in the Minami Aso area, Aso Bridge was collapsed completely, see Figure4, and the connection between Tateno and Kurokawa districts in Minami Aso Village was lost.

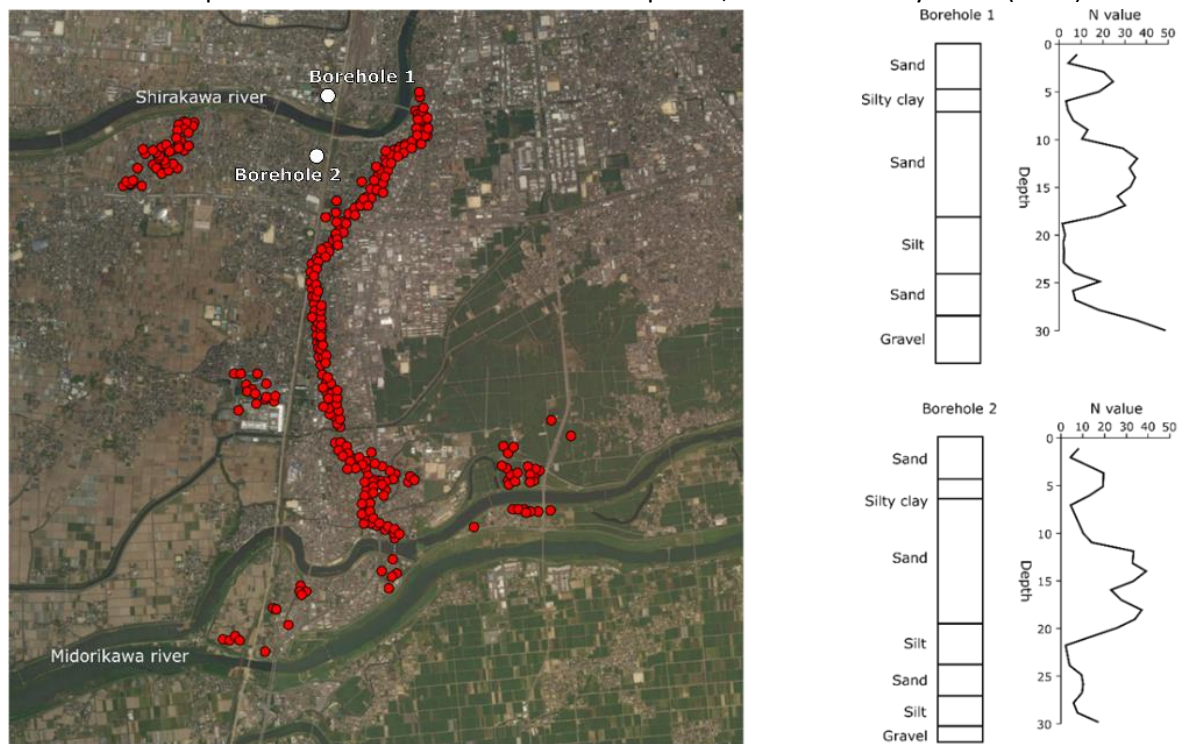
Surveys of the affected area following the earthquake showed signs of sand boiling with ejected sand on the surface. Liquefaction were observed in Kumamoto Port, Akitsu River (Mashiki Town), Kamiezu Lake and a stretch (a rectangular belt) covering 2km by 20m between Shirakawa River and Midorikawa River in Kumamoto City as shown in Figure 5. The possible explanation is that the area was an old natural river dike which was reclaimed. Figure 5 also shows selected borehole profiles along the survey route. The ground consists of Alluvium relatively new deposit overlying Diluvium. The top soil is black colored organic possibly of volcanic nature, locally known as Kuroboku. Simplified JRA code based liquefaction analysis was conducted on the ground profile and it is predicted that 0m to 8m may have liquefied. Typical liquefaction damages in the area can be seen in Figure 6, which shows several buildings show differential settlement in Kumamoto City. It was interesting to note that high rise buildings and most possibly supported on pile foundations performed well except some minor damage

Figure 5: Observed liquefaction along the survey route; (b) Sample borehole data

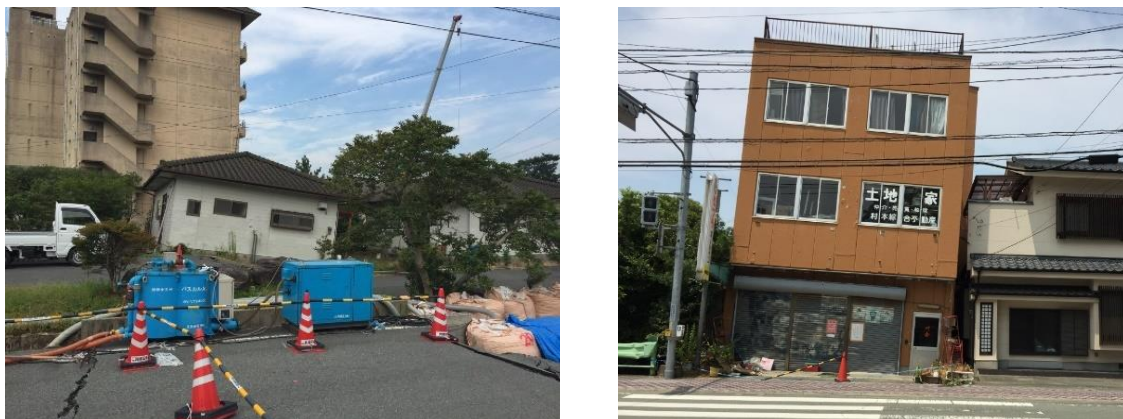
Figure 6: Liquefaction induced damage to buildings in Kumamoto

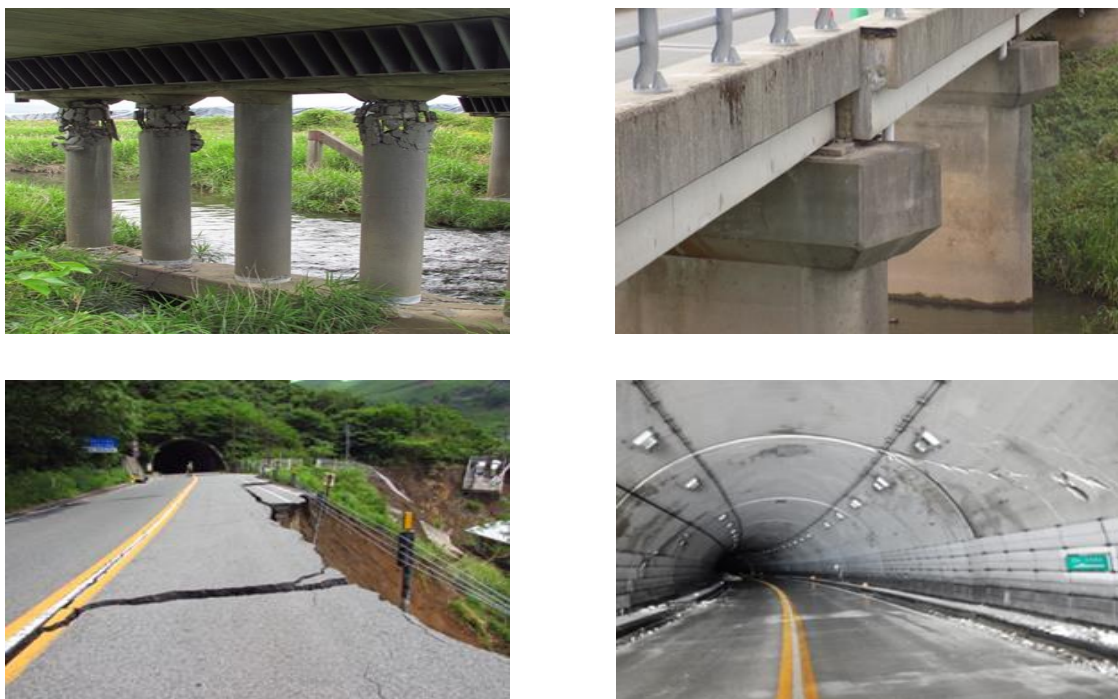
In the southern part of Mashiki Town specifically along Kiyama river, a clear damage was noted on Hatanaka Bridge. Severe settlement at the transition area of bridge and soil ground is apparent. The bridge piers show significant damage especially underneath the pile-cap as well.

Tawarayama Tunnel was located on Road No.28 with 4.5 m high, 7.5 m wide and 2057 m long. It was built in 2002. Several concrete segments lining fell down, which is a huge threat to the tunnel stability beside the development of shear cracking along the tunnel. Settlement along the tunnel was observed, and severe cracking at footing was evident as shown in Figure 10.

Figure 7: Damages to infrastructure; damage to Daiichi Hatanaka Bridge(top left); Damage to a bridge at Akitsu river (top right); Damage to Tawarayama Tunnel (bottom)
